## PROCEEDINGS FOR SOLVING NON-CONFORMITIES OF CAR WIRING SYSTEMS

**Abstract.** The paper presents some proceedings for solving non-conformities identified in car wiring systems. The root causes that lead to non-conformities in different workstations in the production flow are established and the process of designing and using a Poka-Yoke system needed to improve the assembly activities of the clips of the product “HJD Dashboard Wiring Systems” is highlighted. This system also ensures that the risk of non-conforming parts and the operator’s effort in carrying out the activities is reduced. The Poka-Yoke system is in addition to the other means of quality control used in the company. In order to continuously improve the efficiency of the organization, the quality of the product and the process it is necessary to work in a structured approach, with a proper mentality.

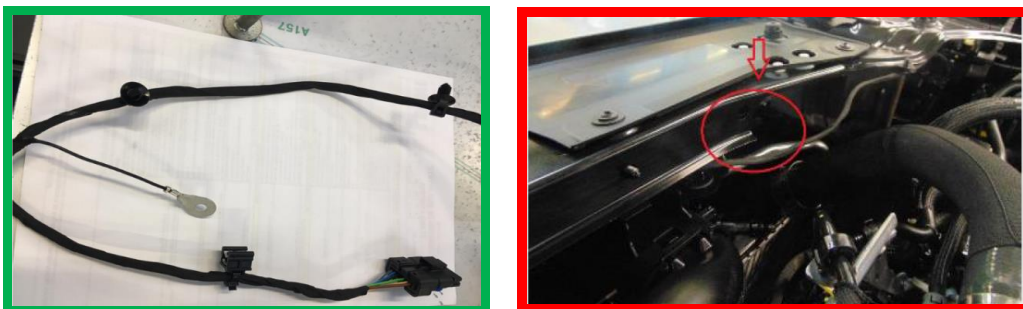
**Fig. 6.** Non-conform product requested by the customer (right) compared to a conform product (left)

Fig. 6 shows the non-conform product “HJD Dashboard Wiring Systems” claimed by the customer, due to the “Missing clip” part, compared to a conform product, which respects the position and presence of the clip.

Following the analysis, using the cause-effect diagram and method 5 *Why?*, two root causes were identified for non-detection and occurrence of this type of defect:

- the counterpart is designed without detection, thus allowing the operator not to insert the clip at the time of cutting and thus influencing the lack of the clip;
- the clamp’ cutting is done manually, with a gun that is set to a force of 150 N; Fig. 8 shows the gun and the manual cutting performed by the operator at the clips table.

The first action taken to eliminate this type of defect was the development and installation of a Poka-Yoke device. Fig. 9 shows the 3D drawing of the device.

The second action implemented to prevent this defect “Missing clip” is the obligation of the operator in the final control station to check 100 % the presence of the clip, according to the quality flash. Fig. 10 shows the quality flash proceeding.

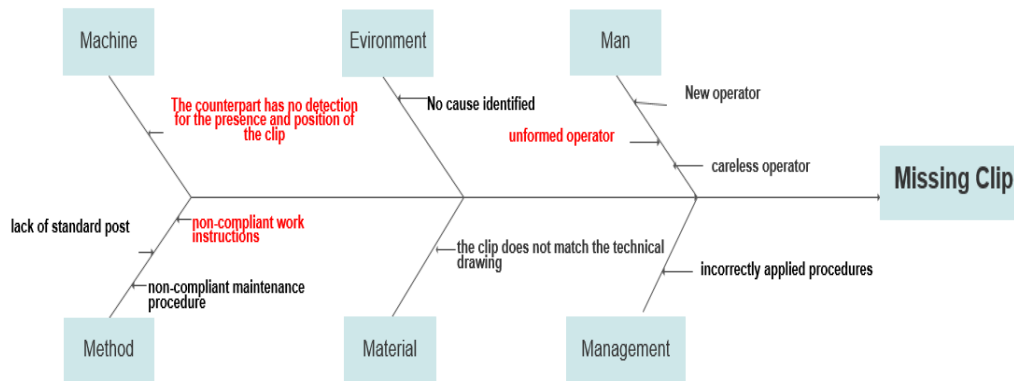
**Fig. 7.** Cause-effect diagram for “Missing clip” defect detection

In order to identify the causes that led to the non-detection and occurrence of the “Missing clip” defect, the cause-effect diagram was made (Fig. 7) [12]. All the factors that could lead to the non-detection of this type of defect were taken into account:

- machine – the workstation where the defect could have been detected; it is at the clips table, where the clip is assembled; the defect was not detected because the counterpart is undetected, there was no Poka-Yoke system;
- man – the operator of this workstation was trained, but after the analysis it was identified that he does not follow the work instructions;
- method – the working instruction and the job standard have been checked, and they are clear and well done, with all the necessary information;
- material – no direct cause was found because the clip matches the execution pattern;
- environment – the workstations are well lit, no direct cause for non-detection of this type of defect;
- management – the proceedings are analyzed if they are complete / incomplete, if they are applied correctly / incorrectly.

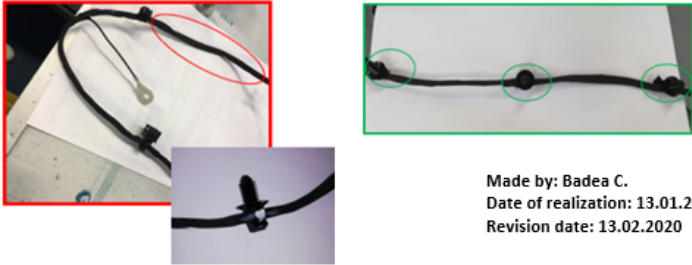
**Fig. 10.** Quality flash proceeding

**Object:** Check position, presence and fixing clip 091

**Tasks:** Check the position, presence and fixing of clip 09 by marking it.

Attest the check by marking it with a white line according to the photo
