PARTICULARITIES OF THE PAINTING PROCESS IN THE AUTOMOTIVE INDUSTRY

Mihaela-Narcisa POPA (STOICA)¹, Emilia BĂLAN²

Abstract. Most of the times, the paint on the cars is considered something that does not require special attention. It is usually associated only with the pleasant appearance of the care. The paint on an automobile is a chemically complex product, the result of a long and complicated technological process. At the same time, it is the most "tortured" element of a car: it has to perform at the highest standards in sun, hail, rain, snow, dust. Therefore, the paint job is one of the most important features a client takes in consideration when buying a car. This paper presents the totality of steps taken towards achieving a paint job of the highest quality. It also states the importance of paint on a car body. The defects that may appear as a result of the painting process are identified, as well as the downstream defects that occurred due to the assembly of parts on the painted car body. Recommendations regarding the elimination of these defects and the extension of paint life are made.

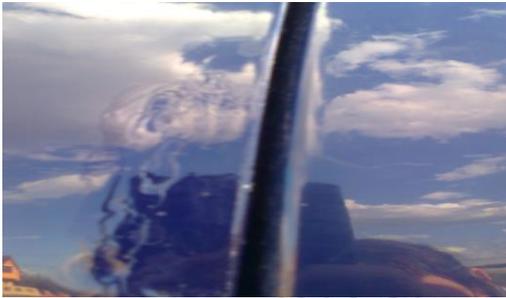
It appears in several forms: like a candle, a wave or a tear (fig. 10).

The generating causes: unregulated gun, failure to observe the application distance of the lake, uncontrolled movement of the operator's hand.

Fig. 10. Paint leak

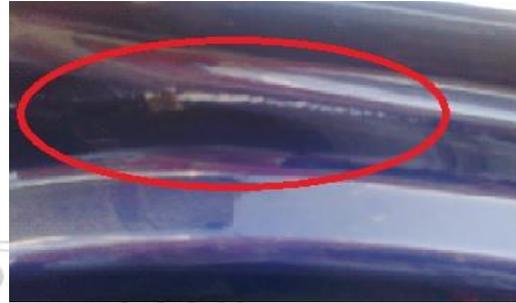
Fig. 11. Lake sticks

This defect can become a generator of nonconformities of the type: **stinging / lake blades** (fig. 11).

The stings are defects rated with a high degree of non-compliance because they cause two major quality problems, namely, related to the corrosive and unsightly appearance. They appear as a result of paint leakage in a large quantity, which in turn, after the drying process, forms air bubbles that subsequently break down and into water, a factor that leads to corrosion of the respective area (rust).

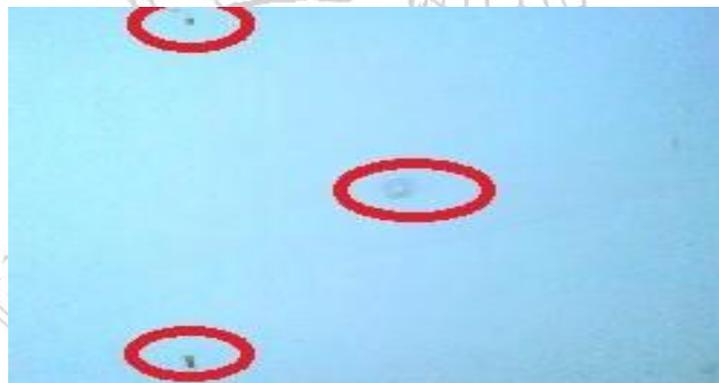
These are very common defects on the surface of the car (fig. 12). They appear either due to the involuntary deposition of particles (dirt) in the paint space, or due to the impurities that are found in the paint (non-filtered paint).

Fig. 12. Paint granules/impurities

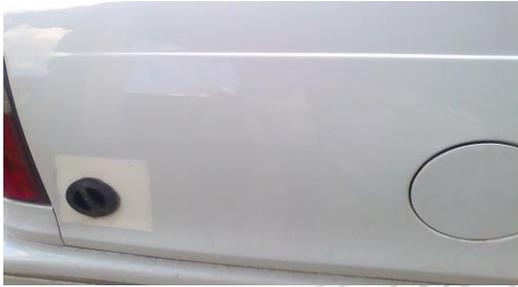
Non-compliant paint (fig. 13) and peeling paint (fig.14), the both defects create the feeling of refusal to look at the respective area.

The generating cause: failure to comply with the standards of preparation of the elements to be painted.

Fig. 13. Non-compliant paint retouches

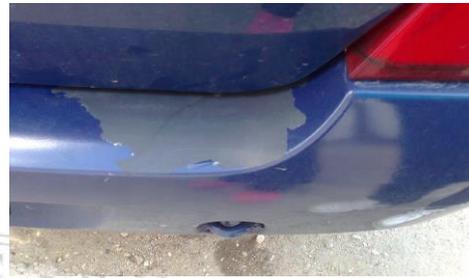
Fig. 14. Rear paint bark peeling

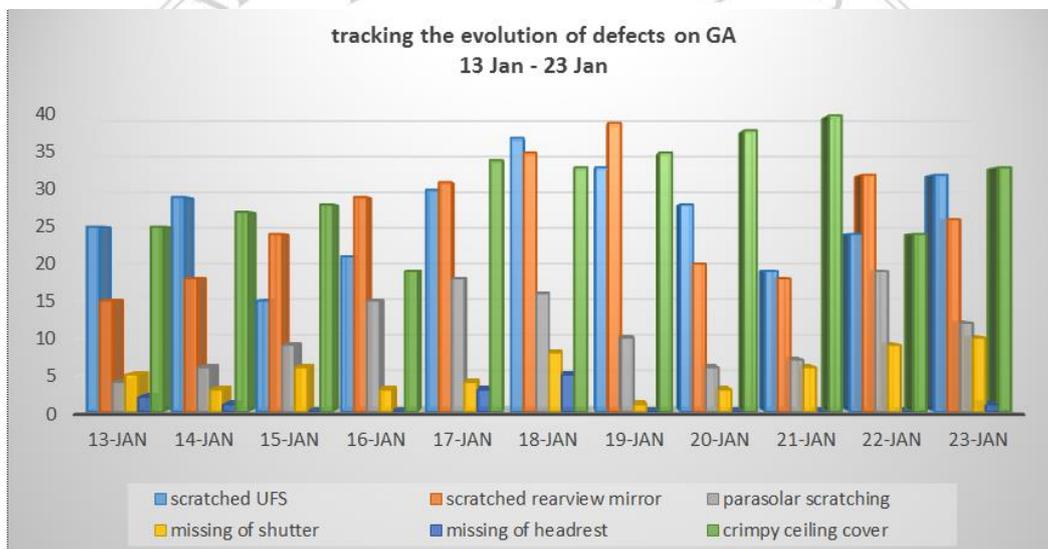
Within the analyzed company, between 13 and 23 January 2020, 2795 vehicles have been manufactured, out of which 1118 vehicles with various defects, from bodywork, painting and assembly and from suppliers (fig. 18). These were identified by the quality operators.

Fig. 18. Defects penalized GA

Out of the total of 1118 non-compliant units, 548 cars can be repaired with the help of qualified operators throughout the entire manufacturing flow, and the remaining 570 cars must be transferred to the retouch area because it requires a long time to repair.

Part of the defects, such as parasol scratching (122 units), missing of shutter (75 units), missing of headrest (15 units) and crimped ceiling cover (336 units) require a short time to remedy if their detection is done in real time.

For this, it is proposed to implement a new working procedure, in accordance with the quality standards, a procedure called "Check-Man Entity". This procedure involves the training, in the field of internal and external quality standards, of the operators of the factory that deal with the verification and control of the different aspects of the vehicle. Thus, these operators will have much more complex knowledge about the quality of the manufactured product. By placing them

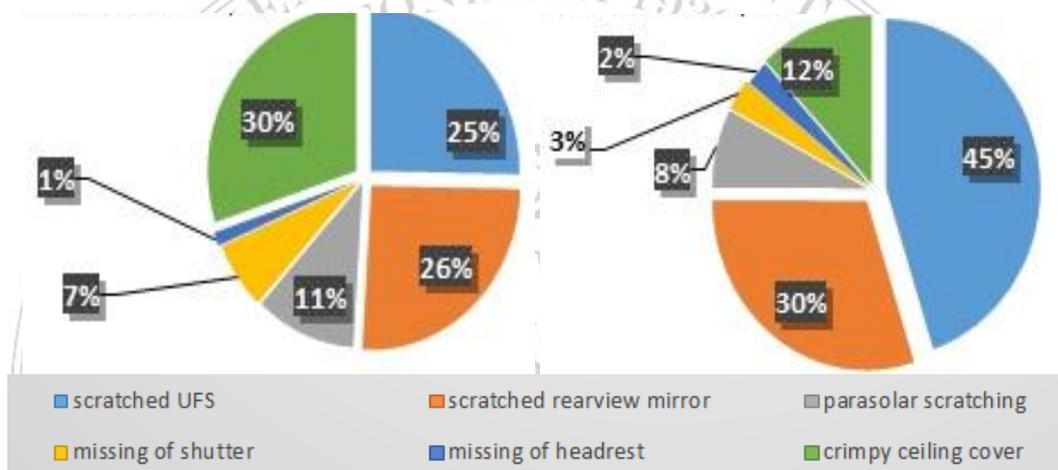
Fig. 19. Space allocated for retouching by types of defects 13 – 23 Jan.

Fig. 20. Space allocated to retouching after implementation procedure 3 – 14 Feb.

Between 3 and 14 February 2020, there is a significant decrease in the stock of vehicles aimed at retouching due to the defect of the crimpy ceiling cover. If between 13 and 23 January there were 336 units corresponding to a percentage of 30 % of the area allocated to retouching, between 3 and 14 February there is a decrease to 40 units (- 296 units), which represents a percentage of 12 % of the surface.

Another significant decrease is due to the sun-scratched defect, from 122 units between 13 and 23 January, with a percentage of 11% of the space, to 25 units (- 97 units) with a percentage of 8 % of the space occupied during 3 and 14 February.

The missing of a shutter defect contributes positively to the decrease of the stock: from 75 units, with a percentage of 7 % of the space on January 13 – 23, to 10 units (- 65 units), with a percentage of 3 % of the space allocated to retouching between February 3 and 14.

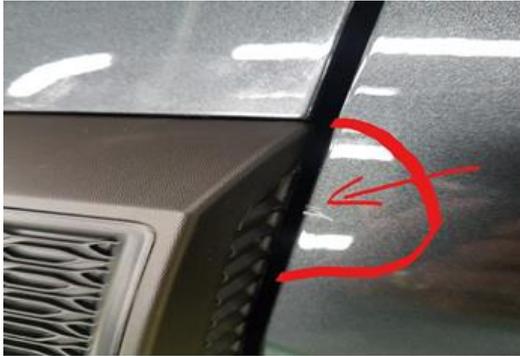
In order to eliminate the defect scratched on the left front door (fig. 21), the causes of its appearance are analyzed. The study starts from the data previously presented in figs. 19 – 20.

Between 13 and 23 January, this defect was registered at 283 units and between 3 and 14 February, there was a decrease of 133 units compared to the previous period. This positive effect is attributed to the implementation of the "Check-Man Entity" procedure. This procedure helps to detect and resolve non-conformities in the technological flow, which leads to a decrease in stocks in the retouching area.

Fig. 21. Defective zone signaling

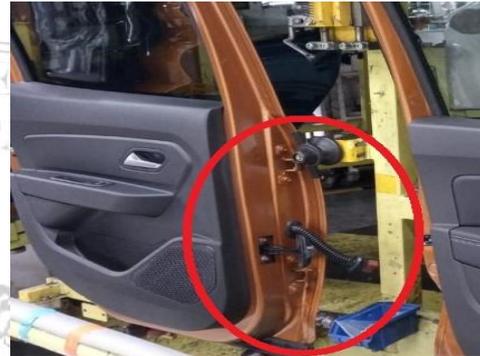
Fig. 22. Door conveyor (swing) [4]

The objective is to obtain zero vehicles with such non-conformities. For this, it is necessary to detect the cause of the defect. Following the information received from the "Check-Man" operators, it was found that the non-compliance occurred due to the damage of the rubber rollers on the balance that carries the equipped doors in the body mounting station (fig. 22).

In conclusion, the root cause of the defect is technological.

The rollers on the conveyor, which have the role of fixing the doors on the swing, are guaranteed to a number of x doors (established by each producer), after which it is necessary to replace them. The time and purchase price of these rolls is high. Therefore, another solution is proposed, with a very short and equally efficient solution time.

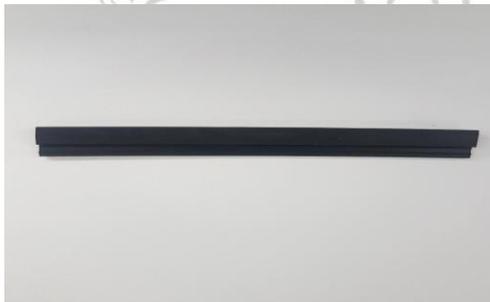
Fig. 23. Rubber protection

The solution consists in sorting the rubber slides (the windows that come mounted on the windows) located in the area dedicated to scrap and sizing them to 15 cm

(fig. 23) to obtain rubber protections. They will be fixed in the area where the doors come in contact with the damaged rollers (fig. 24) of the door conveyor and will fulfill the role of protection for the paint on the doors.

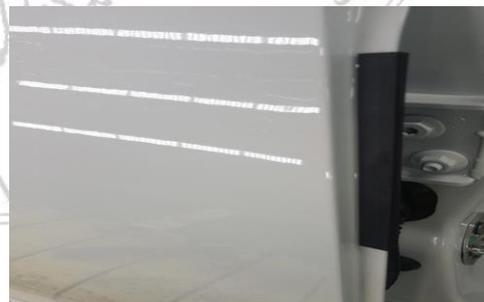
Fig. 24. Protection fixing area
