THE ANALYSIS OF THE PARTICULARITIES OF FLEXIBLE DIES AND OF THE OPTIONS TO ENSURE QUALITY IN FLEXO DIE CUTTING

Abstract. In flexographic printing, die cutting is classified among the operations needed to finish the printed product into pliable end-products, self-adhesive labels, boxes. For the present study, die cutting with the flexible die – magnetic cylinder – anvil ensemble is of interest. The following were analysed: the possibilities for ensuring the quality of the die cut and of the die cutting process, by remedying die cut nonconformities and defects.

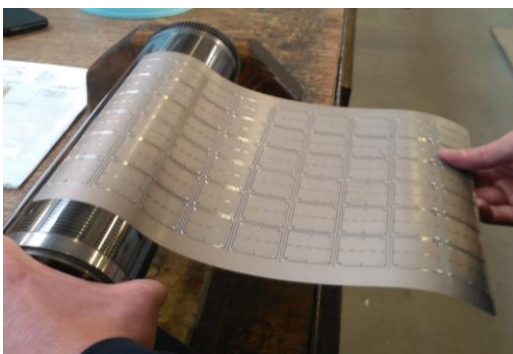
Fig. 1. The die is flat-shaped. It is mounted on the magnetic cylinder by rolling.

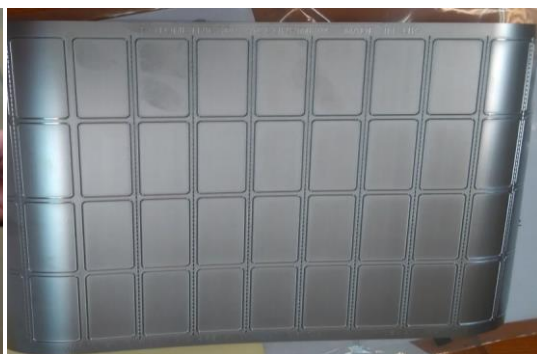
Fig. 2. A flexible die. Its front face is the part with shapes defined by the cutting blades.

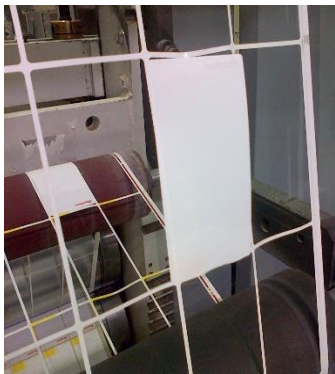
Once destroyed, the edges will not cut correctly anymore, the labels will stay attached to one another through a paper bridge, and the waste will break in that spot (Fig. 3-5). Sometimes this leads to the impossibility of lifting and running the waste matrix by breaking it.

Fig. 3. The label remains trapped in the waste matrix.

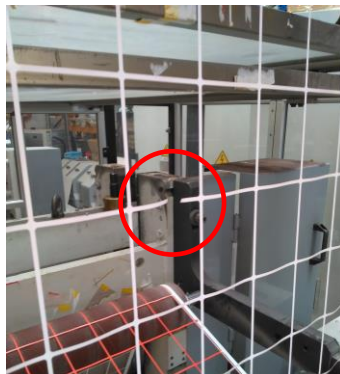
Fig. 4. The waste matrix is broken.

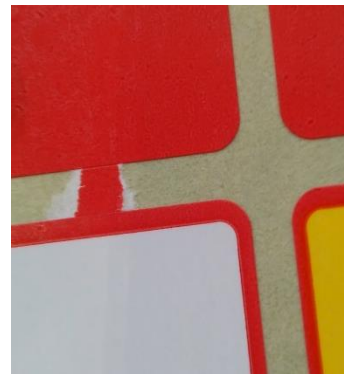
Fig. 5. Incompletely cut labels that remain attached.

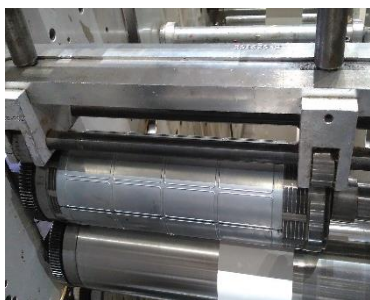
When using the die for a width of material narrower than the die itself, the die is destroyed by the wear of the blades free of material, pressed on the anvil (Fig. 6). On successive printings, the labels in these areas will no longer be cut properly – the die cut removes the labels.

Apparently, the material is saved by using differences from cutting-off a large roll, but in reality the wear of the die cut requires a much earlier replacement. Given the high costs, these types of defects are continuously monitored.

Fig. 6. Die cutting a width of material narrower than the die itself wears out the die.

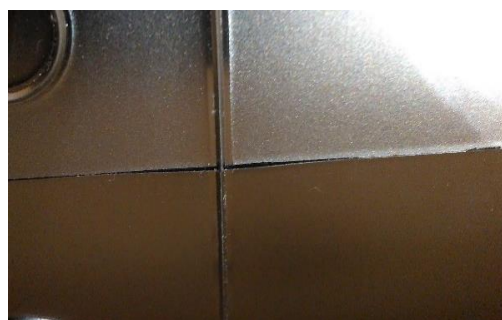
In the analysed case, this area was observed through a 60x magnified image (Fig. 9). Here, the die was cut too short, the longitudinal cutting blade has offset ends, and in the immediate vicinity the die cut overlaps visibly (Fig. 10).

These non-conformities in the execution of the die cut have caused the printing to be interrupted. The pressed material was cut in the elevated area of the die cut, and the lateral cut-off was not possible. These cases are monitored continuously.

Fig. 10. New, non-conforming die cut. The die cut overlaps when mounted, causing the material to cut/tear.

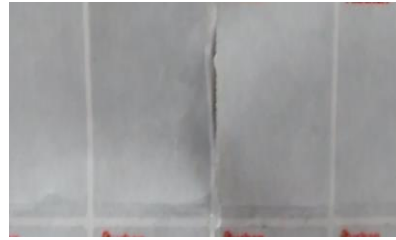
Fig. 12. The die cuts the material, in different places. The area is random on print repetitions.

During production, it was the printing worker who noticed the moment when the die cut stopped cutting the face of the printing material (Fig. 11) or it cut through the material (Fig. 12). The working procedure in these cases involves stopping the workflow, restoring the adjustment to the die, resuming the printing process, recording the losses. So far, no elements that lead to the advance detection of rolls with such problems in advance have been identified.

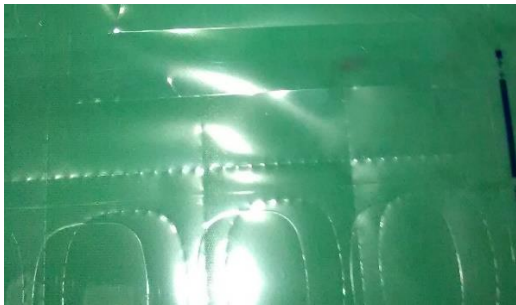
After investigating, it was found that, even though both die cuts were correctly mounted on the cylinders, they were cutting asynchronously (Fig. 14). In order to determine the cause, the following were analysed: the geometry of the cutting blade drawing from each die cut, along with the physically executed die cut and the finished product obtained in production.

Fig. 14. The die cut print generated by perfectly paired die cuts executed independently. The shift in the drawing of the die cut nests is noticeable.

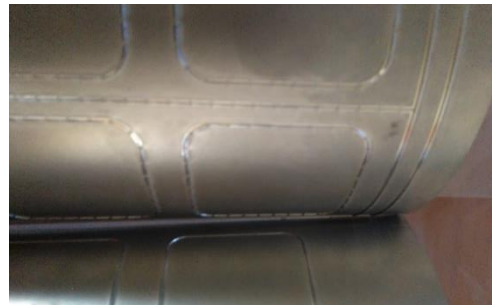
Fig. 15. Matching die cuts independently executed. Checking the nest overlap is done by matching the die cuts at the edge.

It was found that the geometry of the drawing differed between the two die cuts, implying different dimensions for the active area of each die cut. This may mislead manufacturers if they do not consider the fact that the two die cuts must cut the finished product by overlapping in the rotating motion. These die cuts must be perfectly matched.

Ignoring the perfect matching requirement led to separate die cut execution, by placing the cutting blades following independent Cartesian coordinates (Fig. 15), instead of a unique Cartesian marker. In production, the case caused losses until settled. After being approached, the manufacturer remade the die cut.

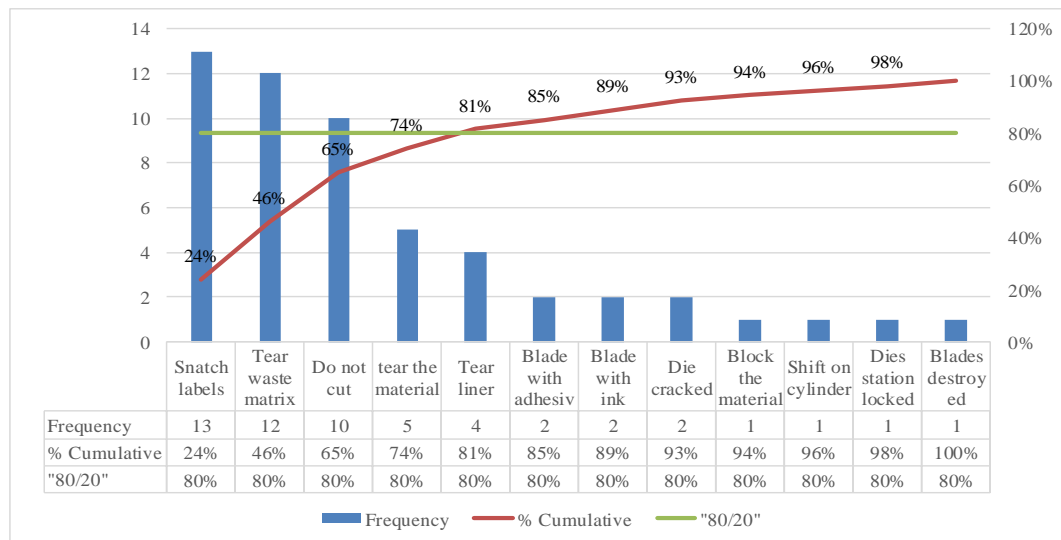
The Pareto diagram presented in Figure 16 shows that, in order to improve the quality of the die cutting process by 80%, the following 20% of the nonconformities and defects produced by die cuts must be eliminated: removal of labels, ridge damage, not cutting the material, breaking the material.

Fig. 16. Nonconformities and defects recorded in the printing process between September 2017 – March 2018.
