THE ANALYSIS OF THE PARTICULARITIES OF FLEXIBLE DIES AND OF THE OPTIONS TO ENSURE QUALITY IN FLEXO DIE CUTTING

Abstract. In flexographic printing, die cutting is classified among the operations needed to finish the printed product into pliable end-products, self-adhesive labels, boxes. For this present study, die cutting with the flexible die – magnetic cylinder – anvil ensemble is of interest. The following were analyzed: the possibilities for ensuring the quality of the die cut and of the die cutting process, by remedying die cut nonconformities and defects.

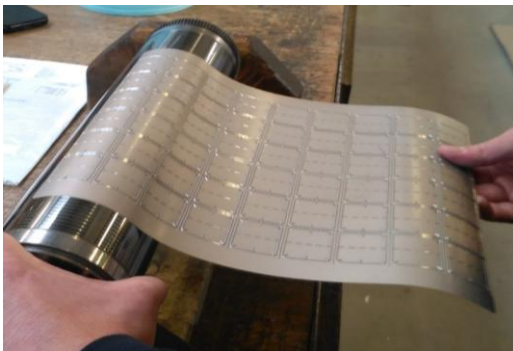
Fig. 1. The die is flat-shaped. It is mounted on the magnetic cylinder by rolling.

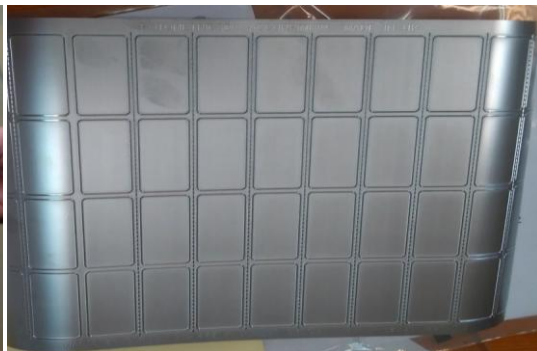
Fig. 2. A flexible die. Its front face is the part with shapes defined by the cutting blades.

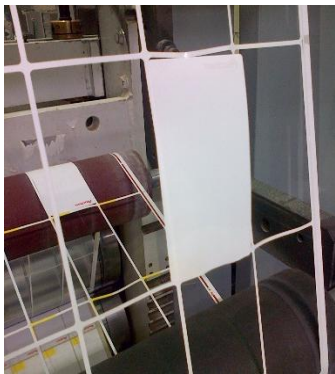
Once destroyed, the edges will not cut correctly anymore, the labels will stay attached to one another through a paper bridge, and the waste will break in that spot (Fig. 3-5). Sometimes this leads to the impossibility of lifting and running the waste matrix by breaking it.

Fig. 3. The label remains trapped in the waste matrix.

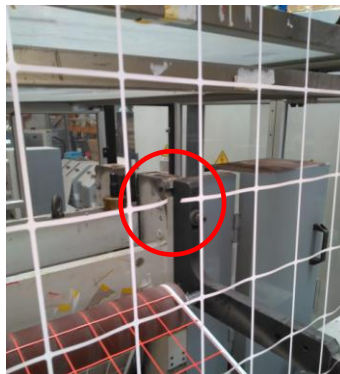
Fig. 4. The waste matrix is broken.

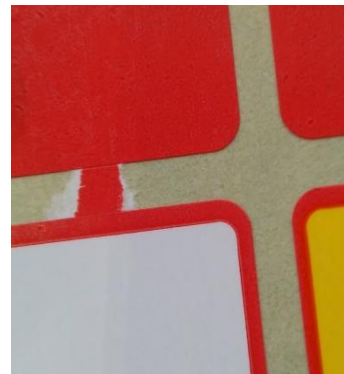
Fig. 5. Incompletely cut labels that remain attached.

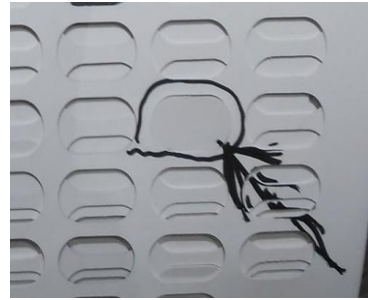
If there is such a mechanical destruction of a die cutting nest (Fig. 7) and this is not observed in good time during the printing process - most often because of the high working speed -, the finished product suffers qualitatively: the waste cannot be removed by die cutting, it remains trapped in the finished product (Fig. 8).

Fig. 8. Waste not removed by die cutting. The product is nonconform.

Removal of the defect is done by replacing the die cut. Cases are rare, but important, due to the large losses they cause.

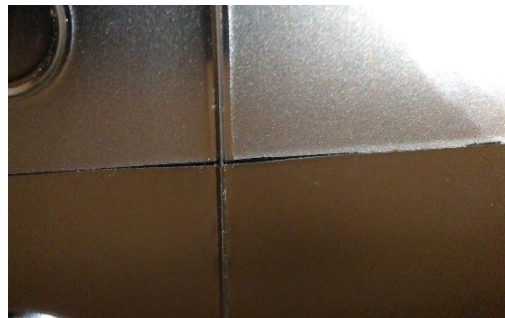
In the analyzed case, this area was observed through a 60x magnified image (Fig. 9). Here, the die was cut too short, the longitudinal cutting blade has offset ends, and in the immediate vicinity the die cut overlap visibly (Fig. 10).

These non-conformities in the execution of the die cut have caused the printing to be interrupted. The pressed material was cut in the elevated area of the die cut, and the lateral cut-off was not possible. These cases are monitored continuously.

Fig. 10. New, non-conforming die cut. The die cut overlaps when mounted, causing the material to cut/tear.

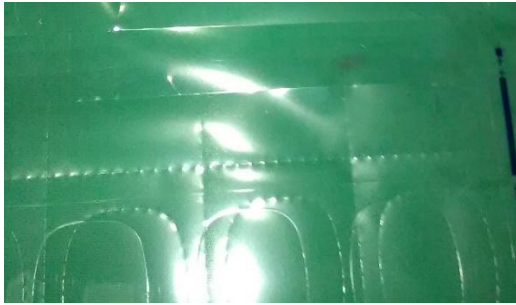
After investigating, it was found that, even though both die cuts were correctly mounted on the cylinders, they were cutting asynchronously (Fig. 14). In order to determine the cause, the following were analyzed: the geometry of the cutting blade drawing from each die cut, along with the physically executed die cut and the finished product obtained in production.

Fig. 14. The die cut print generated by perfectly paired die cuts executed independently. The shift in the drawing of the die cut nests is noticeable.

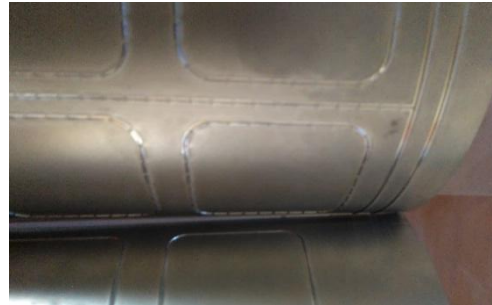
Fig. 15. Matching die cuts independently executed. Checking the nest overlap is done by matching the die cuts at the edge.

It was found that the geometry of the drawing differed between the two die cuts, implying different dimensions for the active area of each die cut. This may mislead the manufacturer if they do not consider the fact that the two die cuts must cut the finished product by overlapping in the rotating motion. These die cuts must be perfectly matched.

Ignoring the perfect matching requirement led to separate die cut execution, by placing the cutting blades following independent Cartesian coordinates (Fig. 15), instead of a unique Cartesian marker. In production, the case caused losses until settled. After being approached, the manufacturer remade the die cut.

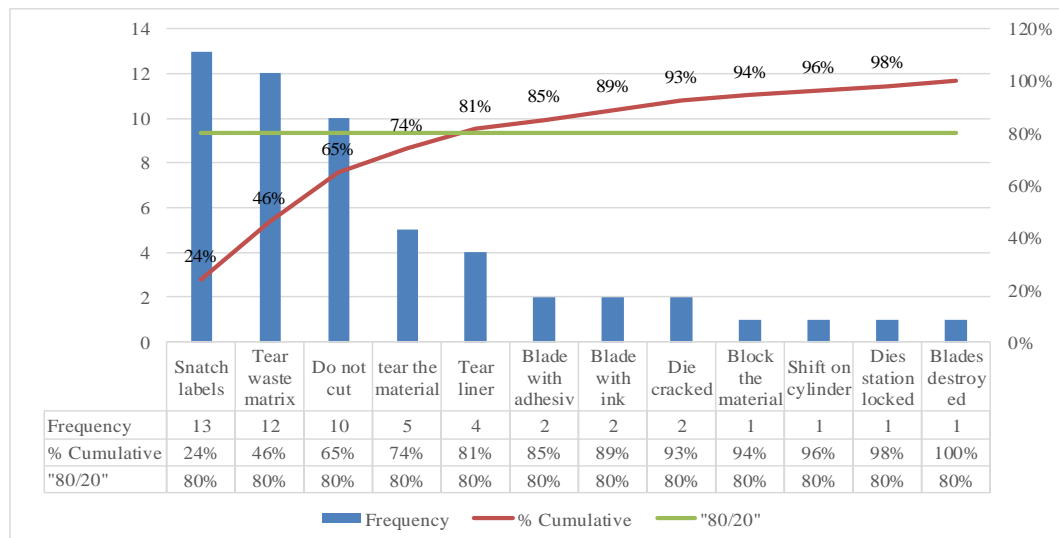
The Pareto diagram presented in figure 16 shows that, in order to improve the quality of the die cutting process by 80%, the following 20% of the nonconformities and defects produced by die cuts must be eliminated: removal labels, ridge damage, not cutting the material, breaking the material.

Fig. 16. Nonconformities and defects recorded in the printing process between September 2017 – March 2018.

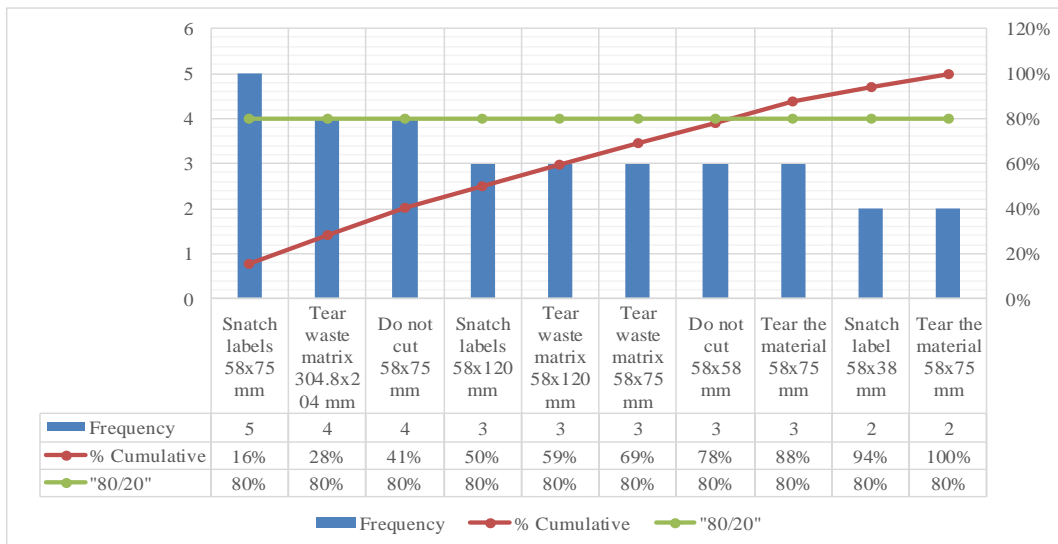
The production data were aggregated monthly, each die cut was matched to the defect found. Thus, information was identified for various types of dies and individual results with non-conformities and defects. In the analyzed period, 80% of the negative effects produced in the printing process were generated by 10 combinations of die-cut defects. Each die cut was named after the size of the die cut contour, expressed in millimeters. The die cuts involved were: 58x38 mm, 58x58 mm, 58x75 mm, 58x120 mm, 107x53 mm, 304.8x204 mm. The analysis revealed that the first four showed an accumulation of defects, which, if eliminated, can lead to an increase in print quality by 80% (Fig. 17).

Fig. 17. Print problems related to the type of die.

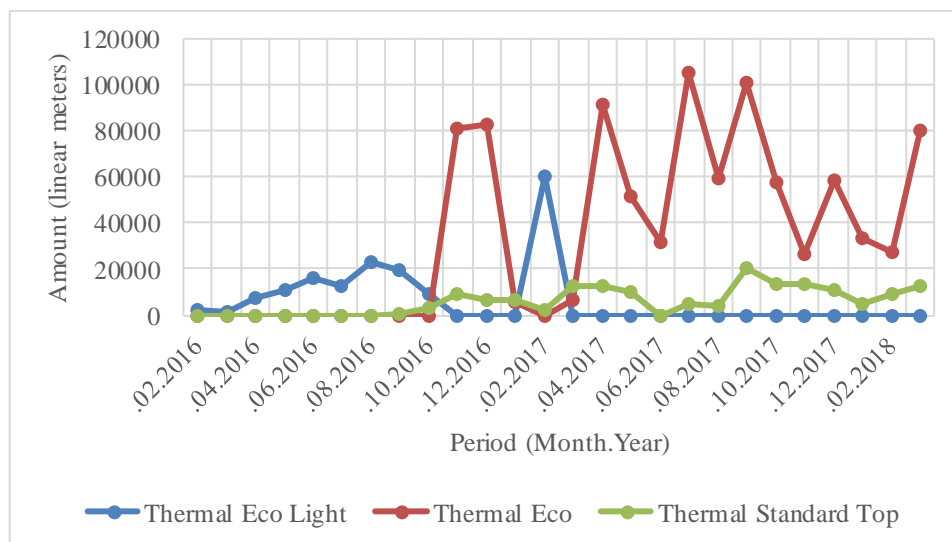
The analysis of the die cut history in production data (Fig. 19) highlights the fact that the die was used to cut 3 types of materials: Thermal Eco Light (the one for which the die cut was ordered), Thermo Eco, Thermal Standard Top. Their features, of interest for the design and subsequent use of the dies in production, are shown in Figure 20.

Fig. 19. The 58x75 mm die: Print history on three types of materials between 02.2016 – 03.2018.

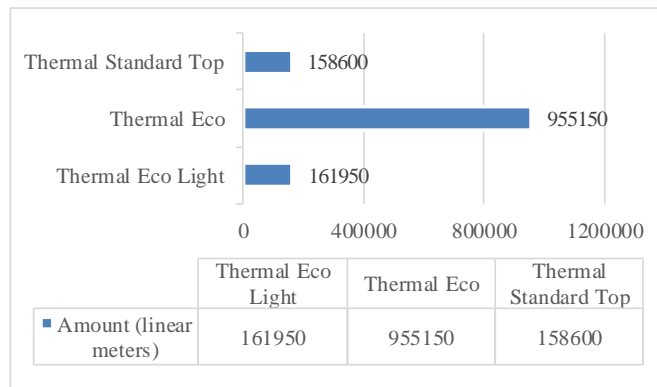
Fig. 21. Amount (linear meters) cut from each material
(February 2017 – March 2018)

Figure 21 shows how the die was mainly used for cutting materials for which it was not designed. The great number of maneuvers for the assembly / adjustment of die repositioning on the magnetic cylinder also contributed to the destruction of the die (Fig. 22).

The analysis of the two charts (Fig. 21–22) shows that the printing numbers for the Thermal Standard Top and Thermal Eco Light –type materials were small but very frequent, while the printing numbers for the Thermal Eco –type material were large and constant.

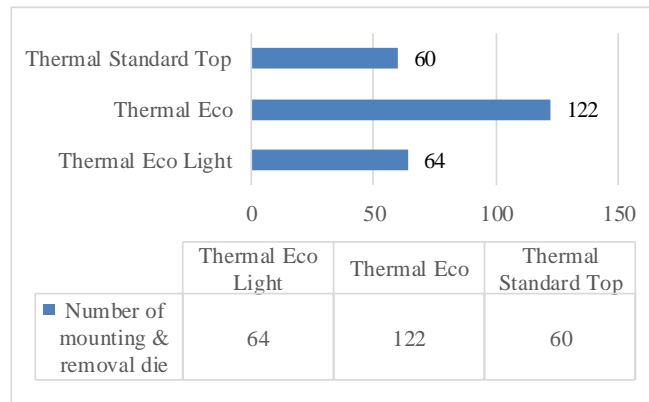
Fig. 22. Number of times the die was mounted & demounted (February 2017 – March 2018)

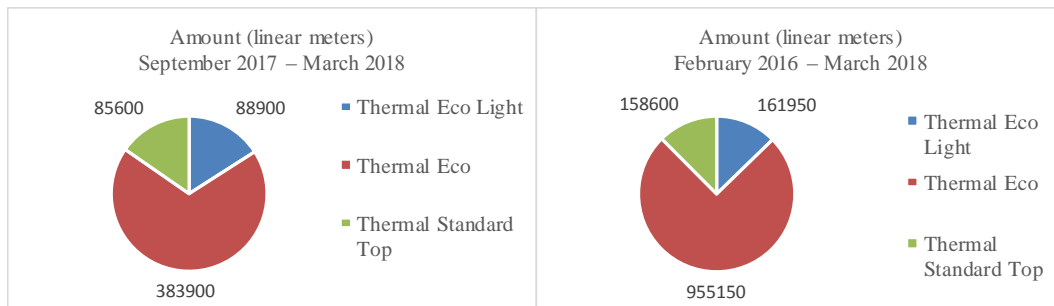
Fig. 23. The 58x120 mm die: comparison between the analyzed period (left) and entire period of use until retiring the die (right).

When the ratio between the 7 month period chosen for the present study and the entire usage period of the die cut of 2 years and 1 month (Fig. 23.) is considered, it can be observed that the two graphic representations are approximately the same: the ratio between the printing values on Thermal Eco Light and Thermal Eco–type support is 1.8, while on Thermal Standard Top–type support it is 2.4.
