THE ANALYSIS OF THE PARTICULARITIES OF FLEXIBLE DIES AND OF THE OPTIONS TO ENSURE QUALITY IN FLEXO DIE CUTTING

Abstract. In flexographic printing, die cutting is classified among the operations needed to finish the printed product into pliable end-products, self-adhesive labels, boxes. For the present study, die cutting with the flexible die – magnetic cylinder – anvil ensemble is of interest. The following were analysed: the possibilities for ensuring the quality of the die cut and of the die cutting process, by remedying die cut nonconformities and defects.

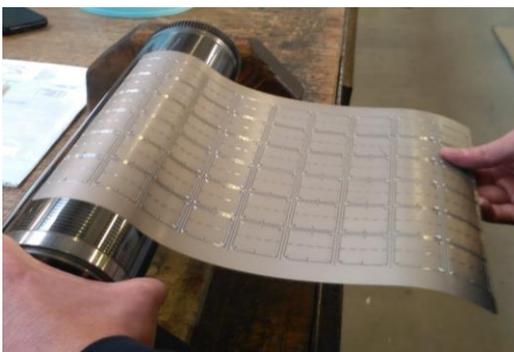
Fig. 1. The die is flat-shaped. It is mounted on the magnetic cylinder by rolling.

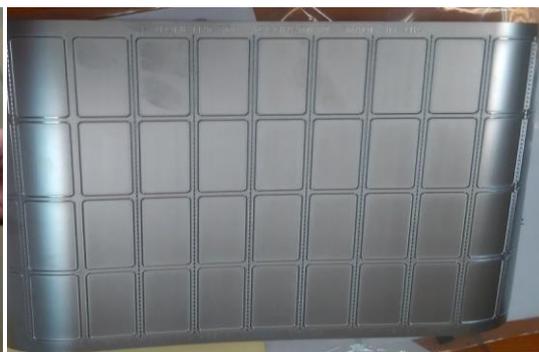
Fig. 2. A flexible die. Its front face is the part with shapes defined by the cutting blades.

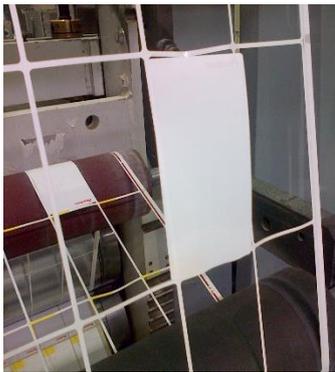
Fig. 3. The label remains trapped in the waste matrix.

Once destroyed, the edges will not cut correctly anymore, the labels will stay attached to one another through a paper bridge, and the waste will break in that spot (Fig. 3-5). Sometimes this leads to the impossibility of lifting and running the waste matrix by breaking it.

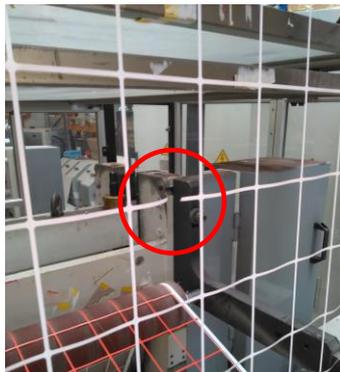
Fig. 4. The waste matrix is broken.

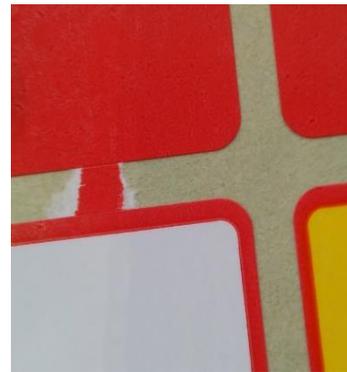
Fig. 5. Incompletely cut labels that remain attached.

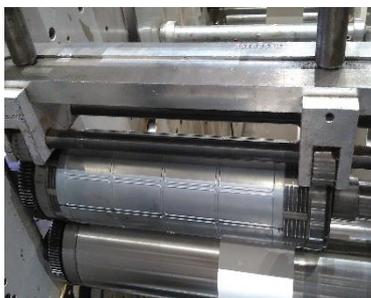
When using the die for a width of material narrower than the die itself, the die is destroyed by the wear of the blades free of material, pressed on the anvil (Fig. 6). On successive printings, the labels in these areas will no longer be cut properly – the die cut removes the labels.

Fig. 6. Die cutting a width of material narrower than the die itself wears out the die.

Apparently, the material is saved by using differences from cutting-off a large roll, but in reality the wear of the die cut requires a much earlier replacement. Given the high costs, these types of defects are continuously monitored.

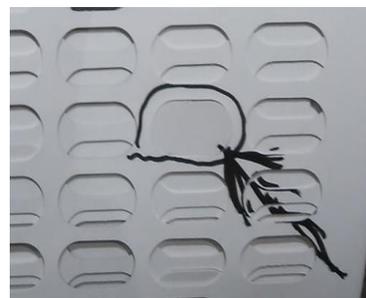
If there is such a mechanical destruction of a die cutting nest (Fig. 7) and this is not observed in due time during the printing process - most often because of the high working speed -, the finished product suffers qualitatively: the waste cannot be removed by die cutting, it remains trapped in the finished product (Fig. 8).

Fig. 8. Waste not removed by die cutting. The product is nonconforming.

The removal of the defect is done by replacing the die cut. Such cases are rare, but important, due to the large losses they cause.

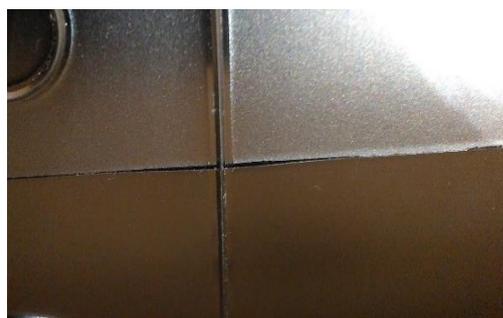
These non-conformities in the execution of the die cut have caused the printing to be interrupted. The pressed material was cut in the elevated area of the die cut, and the lateral cut-off was not possible. These cases are monitored continuously.

Fig. 10. New, non-conforming die cut. The die cut overlaps when mounted, causing the material to cut/tear.

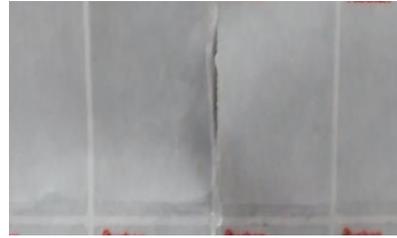
Fig. 12. The die cuts the material, in different places. The area is random on print repetitions.

During production, it was the printing worker who noticed the moment when the die cut stopped cutting the face of the printing material (Fig. 11) or it cut through the material (Fig. 12). The working procedure in these cases involves stopping the workflow, restoring the adjustment to the die, resuming the printing process, recording the losses. So far, no elements that lead to the advance detection of rolls with such problems in advance have been identified.

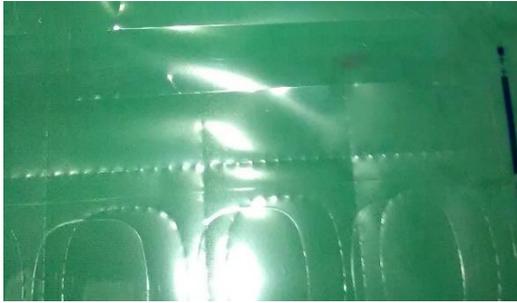
After investigating, it was found that, even though both die cuts were correctly mounted on the cylinders, they were cutting asynchronously (Fig. 14). In order to determine the cause, the following were analysed: the geometry of the cutting blade drawing from each die cut, along with the physically executed die cut and the finished product obtained in production.

Fig. 14. The die cut print generated by perfectly paired die cuts executed independently. The shift in the drawing of the die cut nests is noticeable.

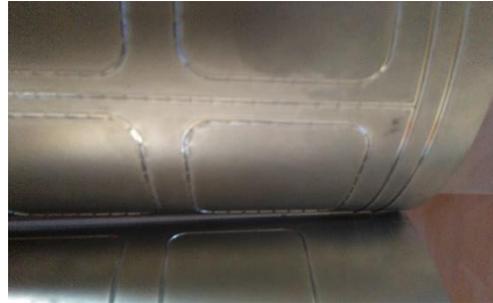
Fig. 15. Matching die cuts independently executed. Checking the nest overlap is done by matching the die cuts at the edge.

Ignoring the perfect matching requirement led to separate die cut execution, by placing the cutting blades following independent Cartesian coordinates (Fig. 15), instead of a unique Cartesian marker. In production, the case caused losses until settled. After being approached, the manufacturer remade the die cut.

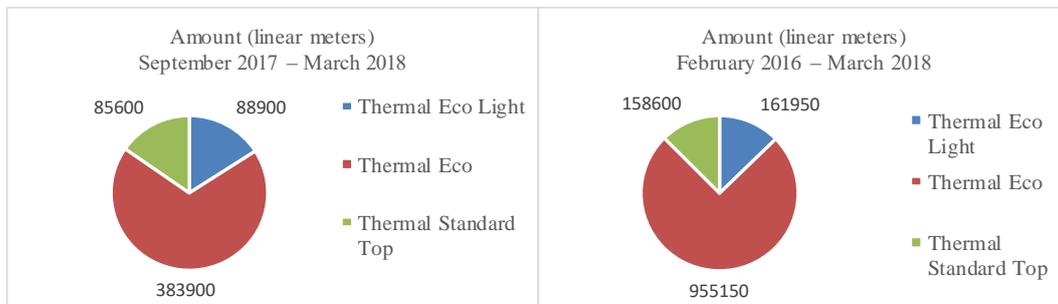
Fig. 23. The 58x120 mm die: comparison between the analysed period (left) and entire period of use until removing the die (right).

When the ratio between the 7-month period chosen for the present study and the entire usage period of the die cut of 2 years and 1 month (Fig. 23) is considered, it can be observed that the two graphic representations are approximately the same: the ratio between the printing values on Thermal Eco Light and Thermal Eco-type support is 1.8, while on Thermal Standard Top-type support it is 2.4.
