STAND TESTING FOR PREFABRICATED BEAMS USED IN THE EXECUTION OF THE SUPRASTRUCTURE OF ROAD BRIDGES

Abstract. *The paper presents the test on the stand of a pre-pressed concrete beam used for the execution of the overpass of roadways. The loading was carried out by means of a hydraulic installation by stepwise application of two vertical concentrate forces. Vertical beam deformations were measured with wire and roller comparators, and specific deformations by electrically resistive tensometry. Are presented the obtained results and their behaviour in loading with vertical loads of pre-compacted concrete beams.*

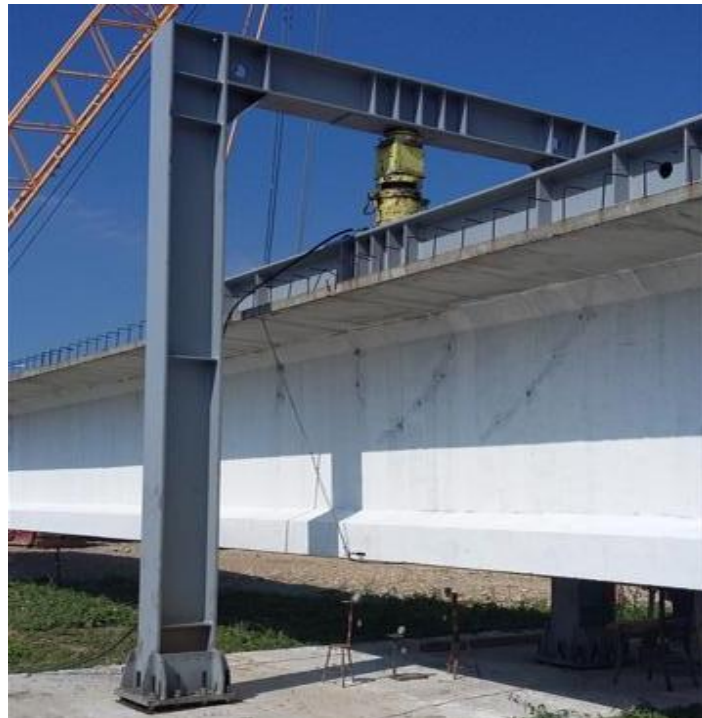
Fig. 1. Detailed frame location, press, intermediate metal beam, tensometric marks, comparators.

The loading was done by means of the hydraulic press located on an intermediate metal beam, supported on two supports (hard wood chips) on the test beam (Fig. 1).

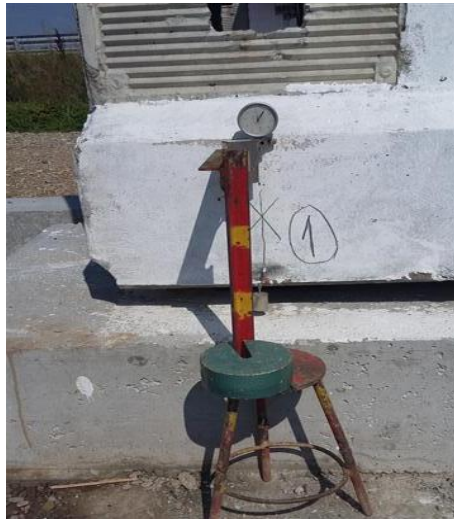
Fig. 4. Detailed positioning on the support.

To measure the arrows, comparators were placed on the supports, at the quarter and in the middle of the beam (Fig. 2, Fig. 3 and Fig. 4). For measuring the specific deformations, the tensometric marks were placed in the middle of the beam, the upper fibre and the lower fibre.

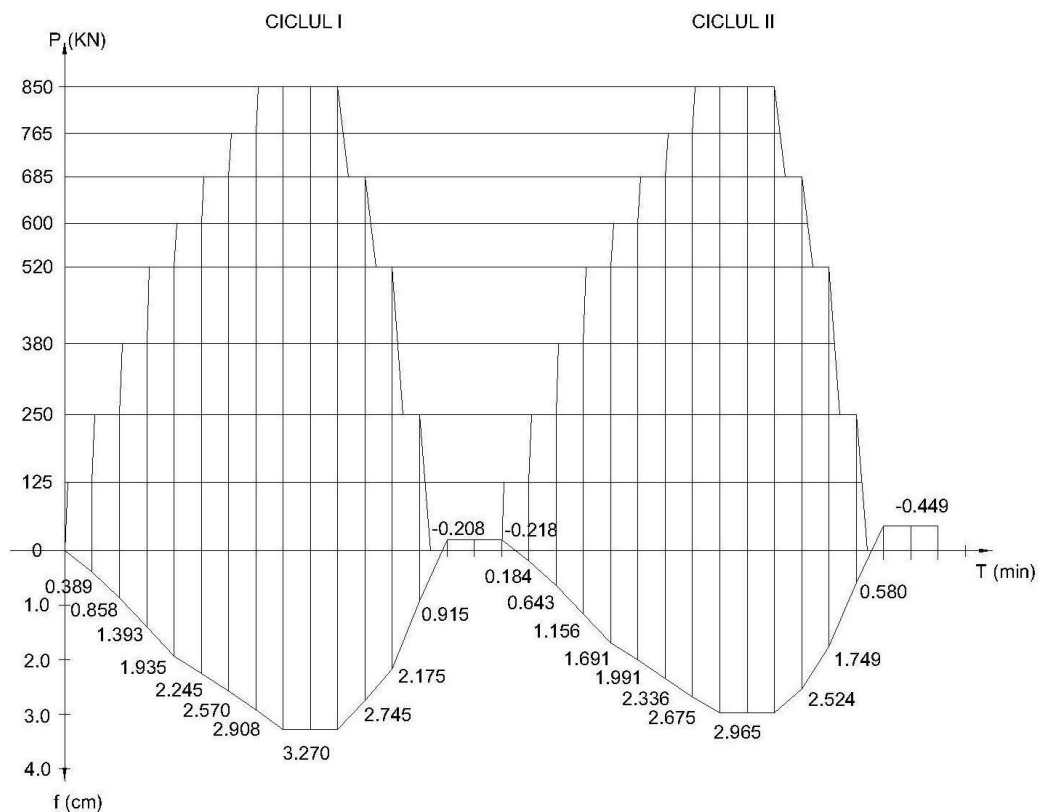
Figure 5 shows the diagram: load - deformation - time.

Fig. 5. Diagram: load - deformation - time.

At the total load of $P = 520$ kN, corresponding to the permanent loads, an average arrow of 1.935 cm was measured in the middle section. At the total load of $P = 850$ kN, corresponding to the frequent traffic loads, an average arrow of 3.27 cm was measured in the middle section, while the unloading remained a 0.218 cm counter-arrow.
