## IMPROVING THE INDUSTRIAL PROCESS OF PAINTING AUTOMOTIVE PLASTIC COMPONENTS

Florentina DINESCU<sup>1</sup>, Dorel ANANIA<sup>2</sup>

**Abstract.** *The paper refers to the improvement of the painting process of plastic parts (bars) in order to ensure an increase of the cadence according to the current requirements production, in quality conditions. The purpose of this paper is to provide ideas for improving the quality of the painted product, thus ensuring the quality of the final product. All large organizations have implemented management methods that can identify the causes that generate defects, but also the actions that can be taken to resolve the problems and to prevent them or other issues. These organisations have state-of-the-art technology and qualified staff in all departments.*

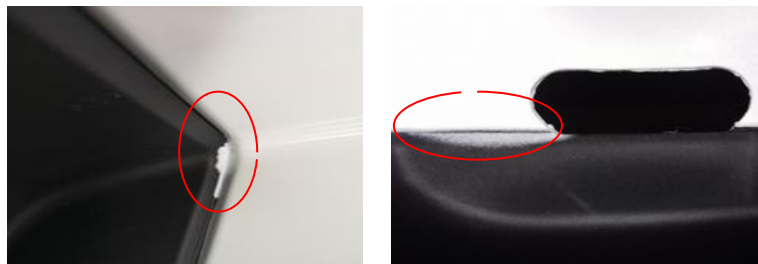
**Fig. 1.** Quality defects caused by inappropriate covering.

- Line of separation not conforming, without continuity, due to the failure to comply with the step which says that the tape path in the separation channel must be well glued, with detached tape areas.

- Gassing, generated by the first operator that did not stick the self-adhesive tape equally, half the template and a half on the panel, then the fineline tape was not applied according to the Standard Operation Sheet, and in the base dyeing step, the robots blow with pressure and the paint penetrates into the area where the bar should remain black.

In the pictures below (see Figure 1: a, b), there are quality defects that can occur in the covering stage.

**a.** Separation line NOK

**b.** Exterior bumper gassing

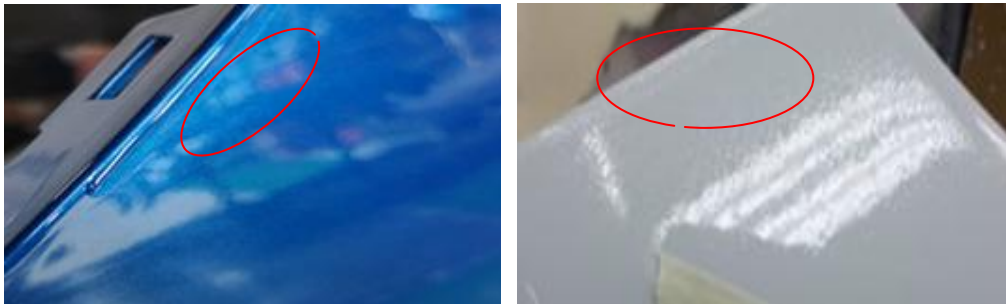
**Fig. 5.** Quality defects generated after application

Generated **defects** (see Figure 5):

- lack of lacquer coating,
- orange peel is a defect caused by causes, such as: too rapid drying of the lacquer, abnormal temperature or the lacquer is viscous,
- stings, is a quality defect that occurs due to a non-optimized temperature, in fact are paint bubbles generated in the base application painting stage but erupting in the lacquer application stage,
- leakages of the lacquer occur due to:
  - the spray application robots are too far away from the bar,
  - the bar material is too thin,
  - the lacquer is blown in other directions by the ventilation in the cabin.

**a.** leakages of the lacquer

**b.** stings

**Actions** required to eliminate these defects:

- Maintaining an optimal temperature in the lacquer application booth,
  - Position robot arms at a suitable distance (30 cm),
  - Ventilation optimization in the lacquer application booth.
-

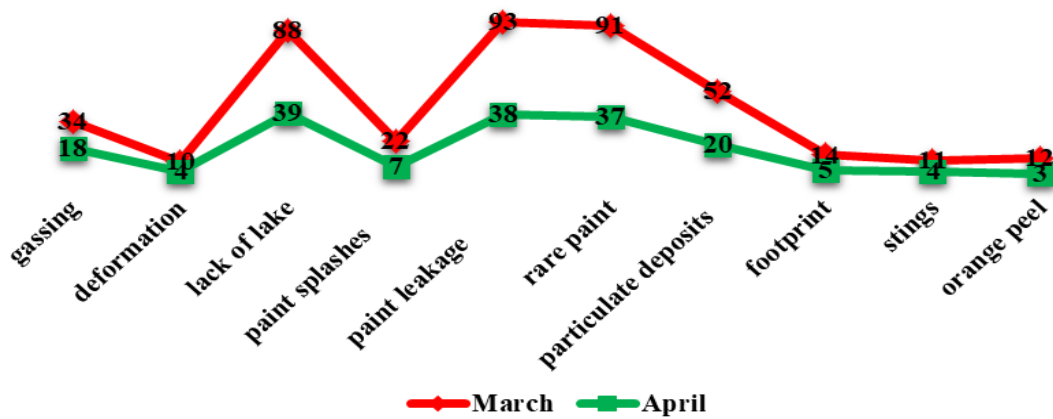
Fig. 6. Evolution of quality defects.

Following the implementation of the actions outlined in the analysis and by observing them by all the operators involved, the number of faults decreased significantly in only one month.

In graphical representation (see Figure 6) it can be observed that the evolution of the defects that occurred in April compared to March is favourable and I want to bring ideas for the improvement of the preparation and painting processes in order to eliminate all the causes that generate the defects of quality.
