## IMPROVING THE TECHNOLOGICAL WELDING PROCESS IN THE CONDITIONS OF SUSTAINABLE DEVELOPMENT

**Abstract.** In the current conditions of sustainable development requirements, it is important to evaluate the activities of companies in the industry. This assessment is important from the perspective of improving the impact of organizations on the environment. The first step towards improving the organizational footprint on the environment is to replace the process of joining flame bonding with laser bonding because the amount of CO<sub>2</sub> emissions generated is minimal, compared to flame bonding where the amount of CO<sub>2</sub> emissions is much higher. A series of theoretical implications are presented that underlie the presentation of a case study that was conducted in a company in the automotive industry. Finally, a series of management activities are presented that contribute to the improvement of the organizational footprint of CO<sub>2</sub>.

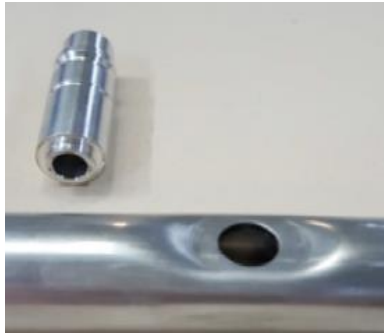
In order to achieve a reliable welding process of the tube where the valve body is found, with ideal quality results, the tube was pressed to obtain a 2D plan in which they are to be welded.

Figure 3 is made before laser welding, and in Figure 4 it can be seen that the deformation of the tube was done correctly after welding.

**Fig. 3.** The tube before welding

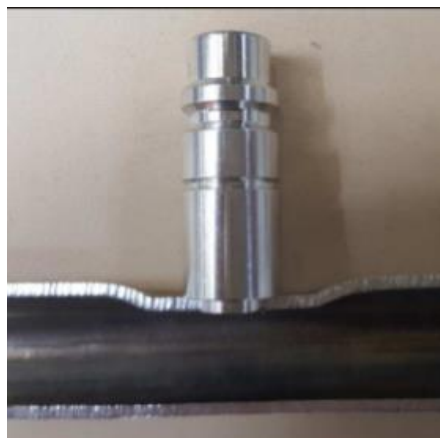
**Fig. 4.** The tube after welding

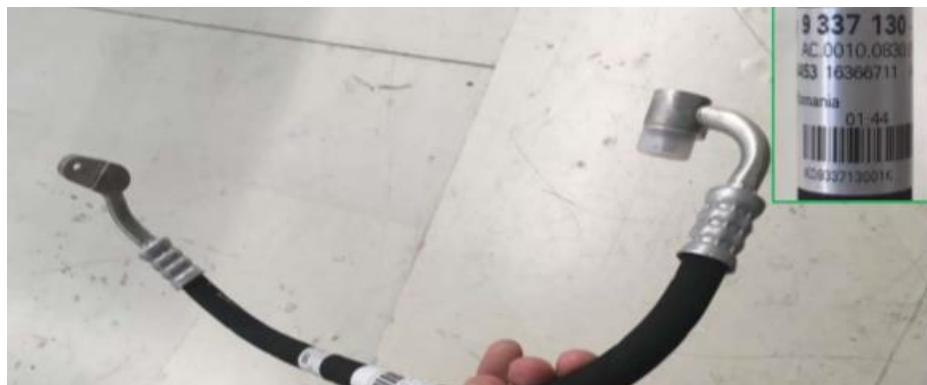
The claimed KM pipes are AC.0010.0830.0100T (according to the helium label). The helium label confirms that the pipe was tightened before delivery.

**Fig. 6.** The identified pipe

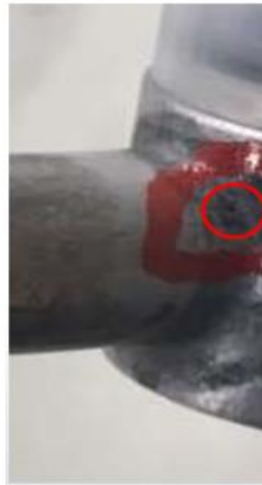
The visual inspection of the pipeline was performed. The gap between the nozzle and the pipe is filled with solder material. The leak was identified in the solder seam as seen in Figure 7.

**Fig. 7.** The drain point

A microscopic analysis was performed. The connecting piece was examined near the sand leak, and part was cut and analyzed under a microscope; it was observed that the distance between the nozzle and the pipe is filled with soldering material; the upper area lacked the soldering material. As such, this is due to the fact that the connecting piece has not been heated evenly.

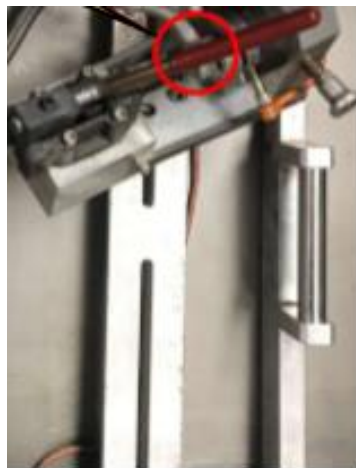
The tightness test was performed. To test the tightness of the pipe, the pipe was tested in a helium chamber. It was found that the piping had leaks, see Figure 8.

**Fig. 8.** Identification of the leakage point

It was found that during the helium test the pipe had leaks. The pipe was leaking due to the fact that the soldering was not done correctly.

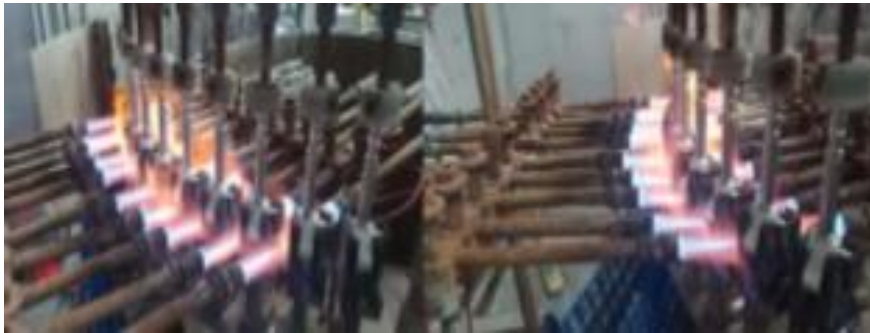
The causes of the occurrence were also evaluated. The solder seam is missing between the connecting piece and the pipe, this is partly due to the setting of the machine. While the machine is adjusted, the flames are adjusted until the connecting piece and the pipe heat up immediately so that the soldering ring melts and the space between the pipe and the connecting piece can be completely filled. Due to the fact that temperature monitoring at the melting point is not possible, several parts are used until the correct setting of the machine is reached.

The setting instructions have been made in more detail to accommodate the adjustments made, to facilitate the configuration of the machine and to reduce the parts used to adjust the machine. The following were evaluated: the distance between the flame and the connecting piece and the positioning of the burners, see Figure 9.

**Fig. 9.** The current situation

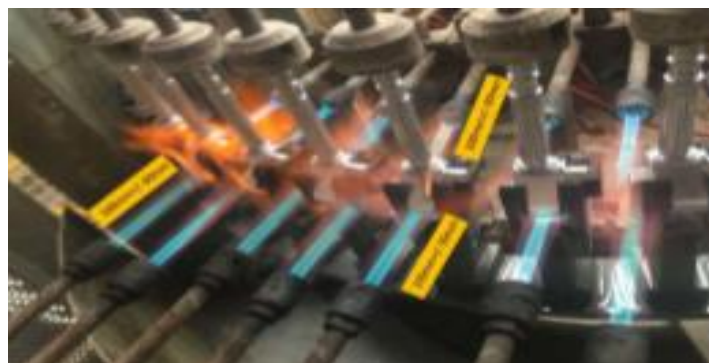
**Fig. 10.** The improved situation

The new working instructions included:

- The distance between the flame and the connecting piece is precisely defined;
- The position of the flame in relation to the connecting piece is presented more explicitly.
