ANALYTICAL EVALUATION OF CRACK PROPAGATION FOR BULB HYDRAULIC TURBINES SHAFTS

Abstract. The Hydroelectric Power Plants uses the regenerating energy of rivers. The hydraulic Bulb turbines running with low heads are excellent alternative energy sources. The shafts of these units present themselves as massive pieces, with cylindrical shape, manufactured from low-alloyed steels. The paper analyses the fatigue cracks occurring at some turbines in the neighbourhood of the connection zone between the shaft and the turbine runner flange. To obtain the tension state in this zone ANSIS and AFGROW computing programs were used. The number of running hours until the piercing of the shaft wall is established as a useful result.

Keywords: bulb turbines, horizontal shafts, fatigue cracks, crack propagation

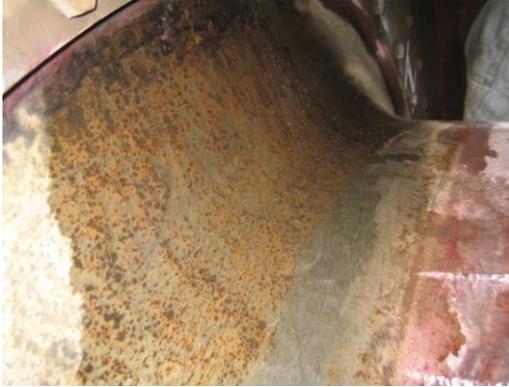
In Tables 5 and 6 there are presented characteristics of the employed material. From the chemical composition (Table 5) it results, that the material is light manganese alloyed steel. The low proportion of chromium and nickel (especially chromium) is inadequate to confer a good resistance to corrosion, inclusive inter crystalline corrosion. Taking into account the influence of manganese on the crystalline grains, we appreciate that the principal alloying element determines a rough structure of the flange material, especially for casted pieces (great and non-uniform dimension of the grains). Therefore, the corrosion resistance of the material is relatively low.

Fig. 2. Spot corrosion (HA 1).

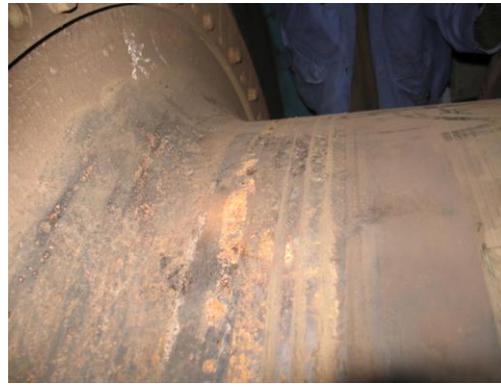
Fig. 3. Corrosion disposed on circumference (HA 8).

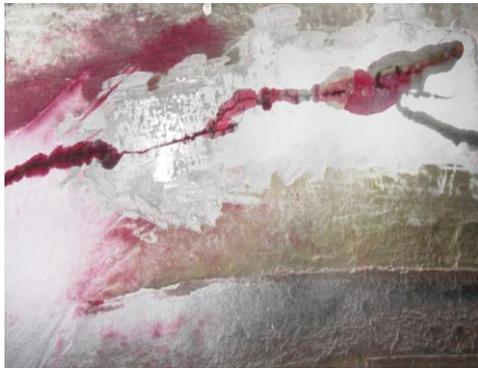
The most dangerous are the great extension cracks. Figure 4 gives a typical example. Approximately in the same cross section, and at the same time, appeared a few distinct fracture lines.

Fig. 4. Great extensions cracks.

In Figure 4, there are three such fissures. In time, all the fracture lines grow on both circumference and depth. The two fissures on the right side of the figure progressed very much in the depth (the thick line of the penetrated liquid) before establishing a small connecting way between them and the fracture line in the left side of the figure. Because the great depth of the fracture lines the repair work is difficult, expensive and does not give sufficient assurance. From case to case, the shaft replacement is advisable. The manner of forming and evolution of those cracks is proper to the pieces having structural faults (chromium carbides, great and heterogeneous crystalline grains) and incorrectly machined (too great roughness). From the loading point of view the variable stress amplitudes is great relatively to the mean stresses. In the continuation, only the great and deep fracture lines will be treated.

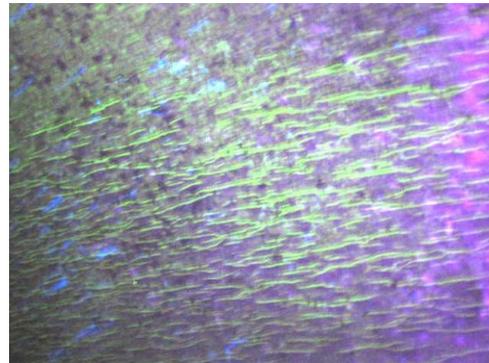
- cracks with great depth and extension (see Figure 4);
- multiple but rarely small extension cracks, disposed in parallel planes;
- multiple and abundant small extensions cracks, disposed in parallel planes (see Figure 5).

Fig. 5. Numerous small extension cracks.

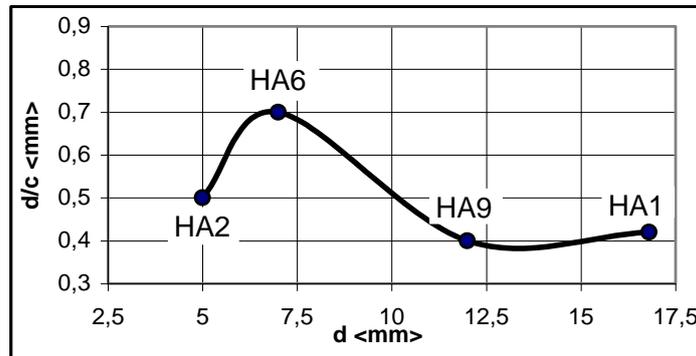
ratio between the crack depth and length to have modifications from one zone to another as result of composition and structure unevenness. A graphic representation of the disposable data is given in Figure 6 and is difficult to explain. In the future, the beneficiary must demand, in this direction, information that is more detailed.

Fig. 6. Dependence of measured d/c against d.

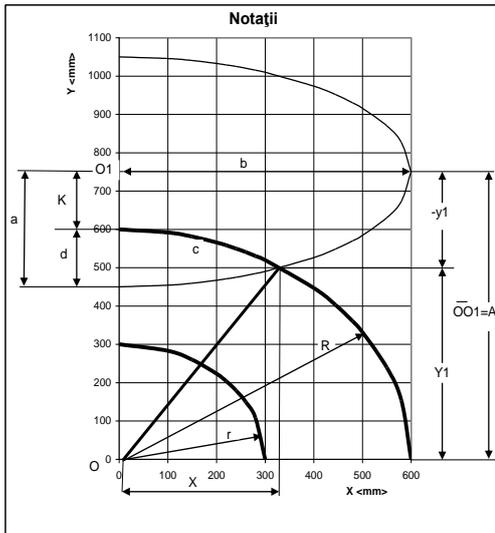
Fig. 7. Notations

To determine the crack semi-length “ c ” is needed the angle α (in circular measure) made by the radius, which goes through the crack end and the ordinate axis (see Figure 7). The equations are:

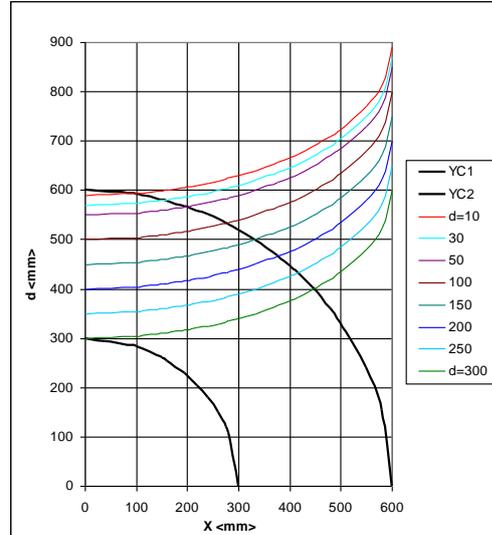
Fig. 8. Intersection shaft/cracks

In Figure 8 is presented the ellipses family with the same value $a/b = 0.5$ for different depths “ d ”, for a quarter of the shaft. The lines representing the external and internal circles of the shaft were notated with YC1 and YC2. With the obtained

The number of hours for the fracture line propagation was added to the initiation number of hours. With the previous conditions, the crack increase until $d = 16$ mm, $2c = 64$ mm is obtained after 153,243 hours. It is important to know that after only 159,737 service hours the crack pierces completely the shaft wall (the curve $d = 300$ in Figure 8 is reached).

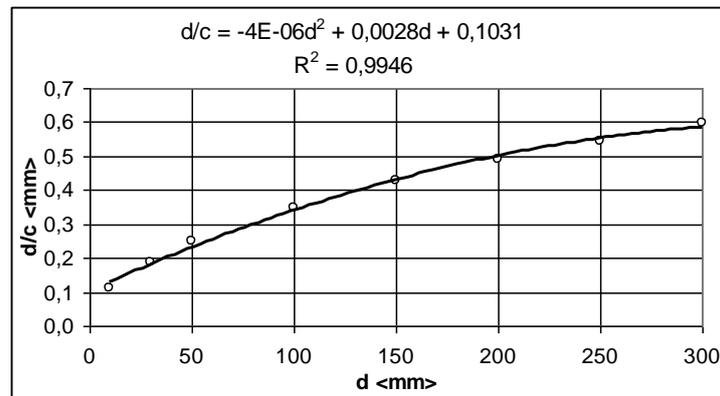
data were computed the semi-cracks length (Table 8). The variation of the ratio d/c against d is shown in Figure 9 together with the equation and the square value of the correlation coefficient. For the determination of the values d/c for small crack depth (around the measured values) was used the regression equation (given in Figure 9). The comparison between the measured crack length and those obtained through computation is given in Table 9. From the comparison a these values it results that taking the ratio $a/b = 0.5$ for the ellipse semi-axis offer covering results,

Fig. 9. Variation of d/c for the considered ellipses family.

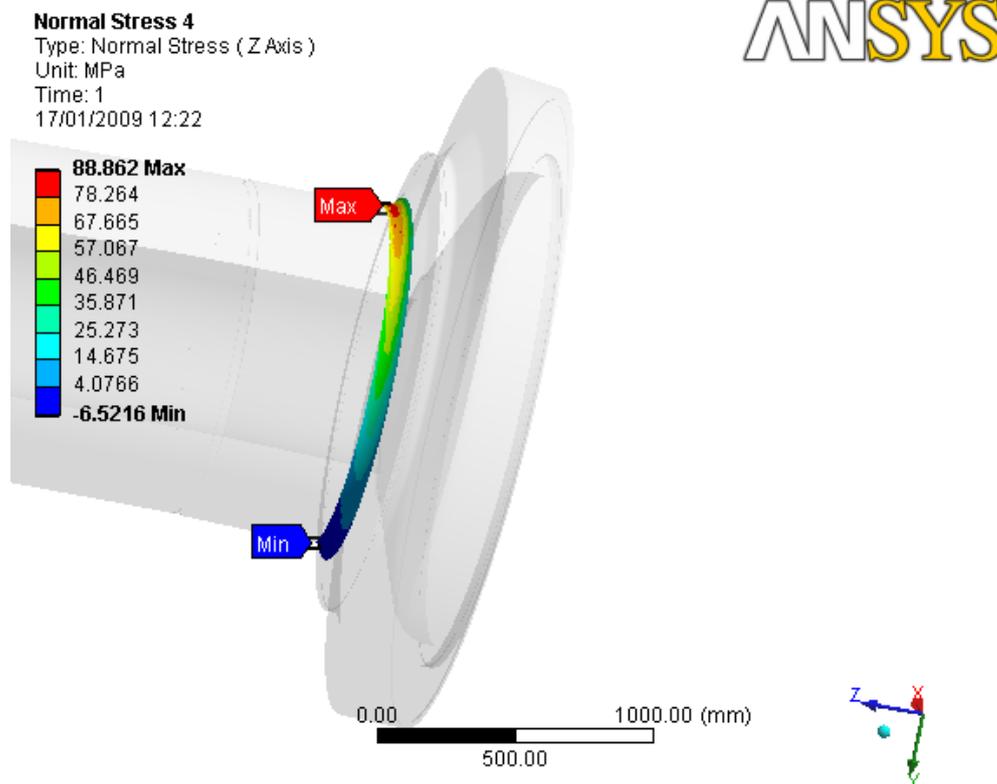
Fig. 11. Normal stress σ_z distribution.

The obtained results indicate the presence of the stress concentration at the connection between the flange and the main shaft body. The maximum equivalent stress being of 105.98 MPa is smaller than the admitted stress of 150 MPa. We consider that from the point of view of “Material strength” the design was correct. The coefficient of stress concentration in the connection zone flange-shaft, determined for the equivalent stress is:

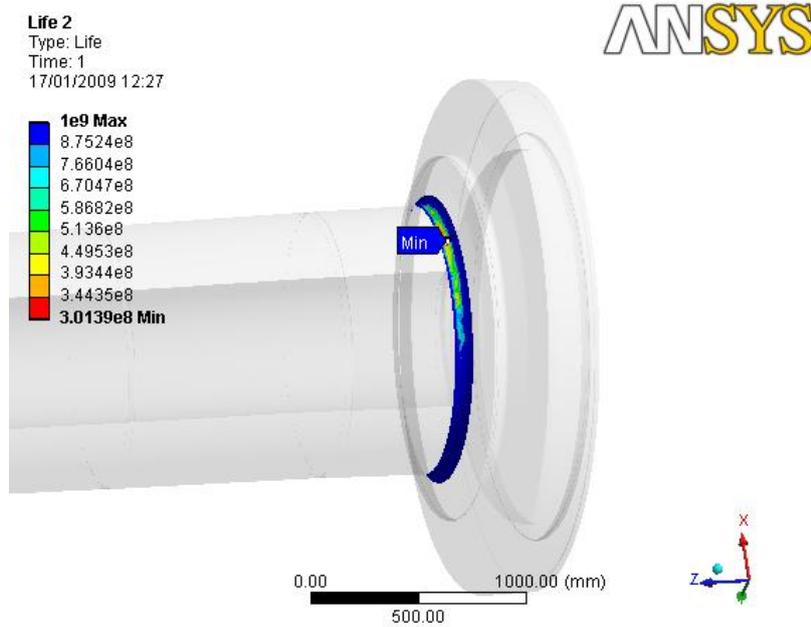
Fig. 12. Cycles number until crack initiation.

After using the fatigue module (FATIGUE TOOL) of the ANSYS v.11 program [2] resulted a minimum duration, until the fissures initiation, of $N_i = 3.0139 \times 10^8$ cycles, equalling 80370 running hours.
