## PROCEEDINGS FOR SOLVING NON-CONFORMITIES OF CAR WIRING SYSTEMS

**Abstract.** The paper presents some proceedings for solving non-conformities identified in car wiring systems. The root causes that lead to non-conformities in different workstations in the production flow are established and the process of designing and using a Poka-Yoke system needed to improve the assembly activities of the clips of the product “HJD Dashboard Wiring Systems” is highlighted. This system also ensures that the risk of non-conforming parts and the operator’s effort in carrying out the activities is reduced. The Poka-Yoke system is in addition to the other means of quality control used in the company. In order to continuously improve the efficiency of the organization, the quality of the product and the process it is necessary to work in a structured approach, with a proper mentality.

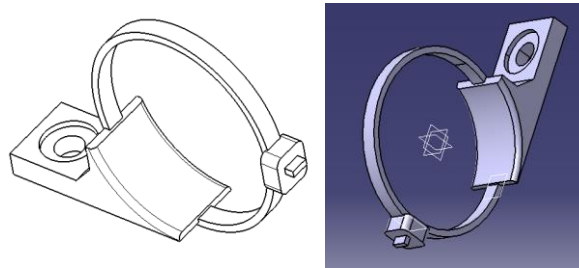
**Fig. 3.** 3D drawing for the piece "clip"

The complaint "Missing clip" was received for the product "HJD Dashboard Wiring Systems". The clip (Fig. 3) is needed to assemble the wiring system on the dashboard of the car.

This complaint was rated with a V1/A gravity indicator that reserves 10 points, the consequences being the impossibility of mounting which causes 1 point, and the number of non-conform parts is 1 wiring system.

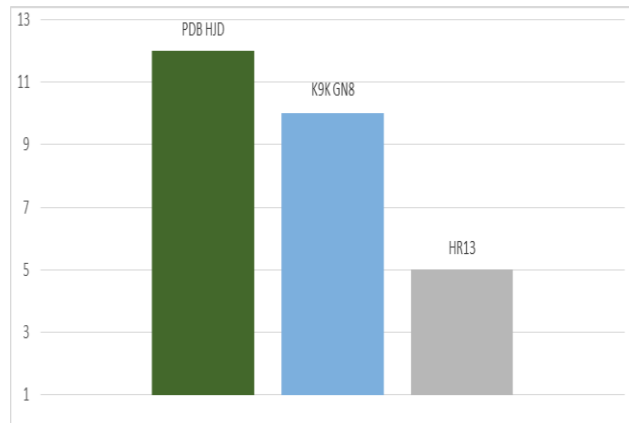
**Fig. 3.** Number of external defects registered in January 2020

January was chosen for the case study, as most of the complaints were registered this month. "HJD Dashboard Wiring Systems" complaint is in the top 3, being in the first position in terms of number of complaints. Fig. 3 shows the number PPM of the external defects registered in January 2020.

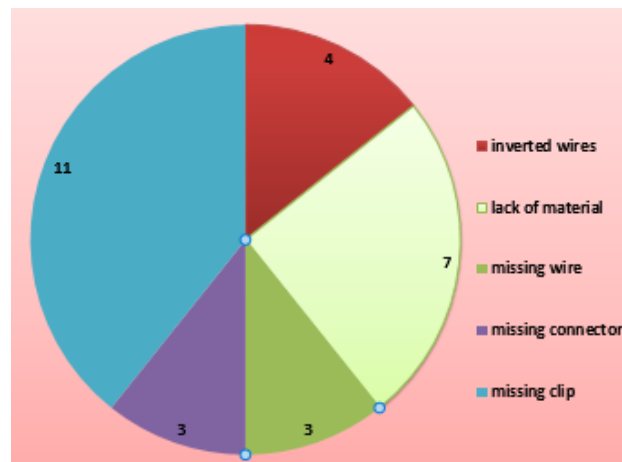
**Fig. 4.** Number and type of internal defects registered in January 2020

Fig. 4 shows the number and type of internal defects registered in January 2020.

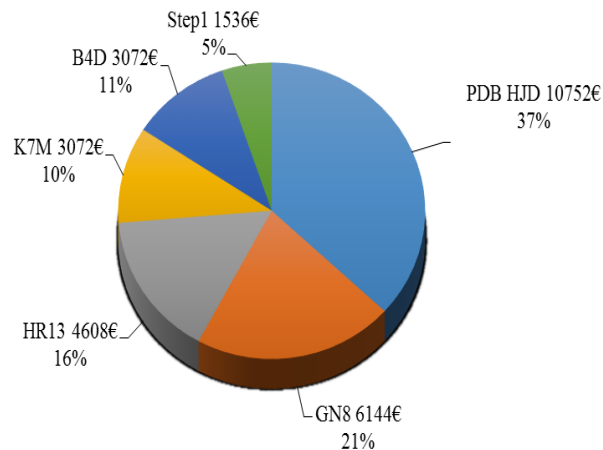
**Fig. 5.** Sorting cost for different products recorded in January 2020

In January it is observed that the highest costs for sorting the parts of different products are recorded for the product "HJD Dashboard Wiring Systems" (Fig. 5).

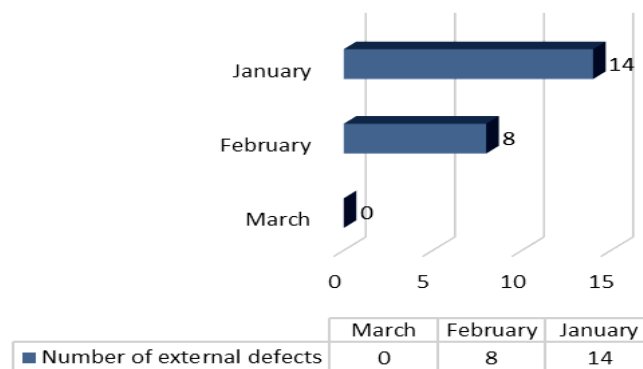
**Fig. 11.** The evolution of external defects in the three months

The attestation of the fact that improvements have been made is observed in Fig. 11 - 14 where the evolution of several indicators is presented.

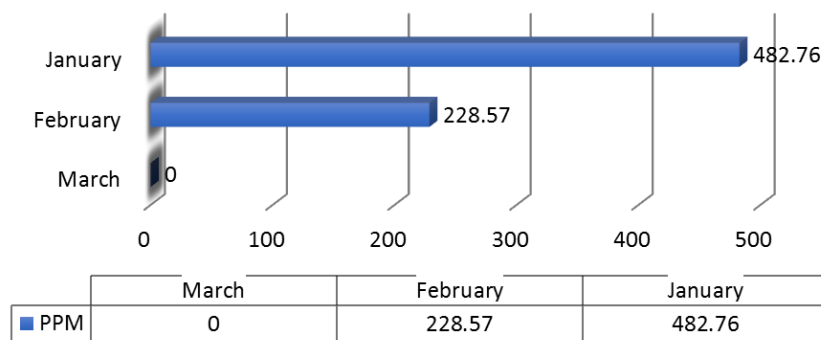
**Fig. 13.** The evolution of the PPM indicator in the three months

The value of the PPM indicator in January is 482, and in March it is zero following the implementation of Poka-Yoke devices and the quality flash proceeding (Fig. 13). After the improvement of the process, the number of defects decreased considerably, which led to a decrease in the cost of sorting.
